# Commissioning and Energy Management Bring Efficiency and Savings to School Campus: A Case Study

**Andy Heitman, CxA, EMP, CEM**

*Building Energy Sciences, LLC*

April 30, 2015

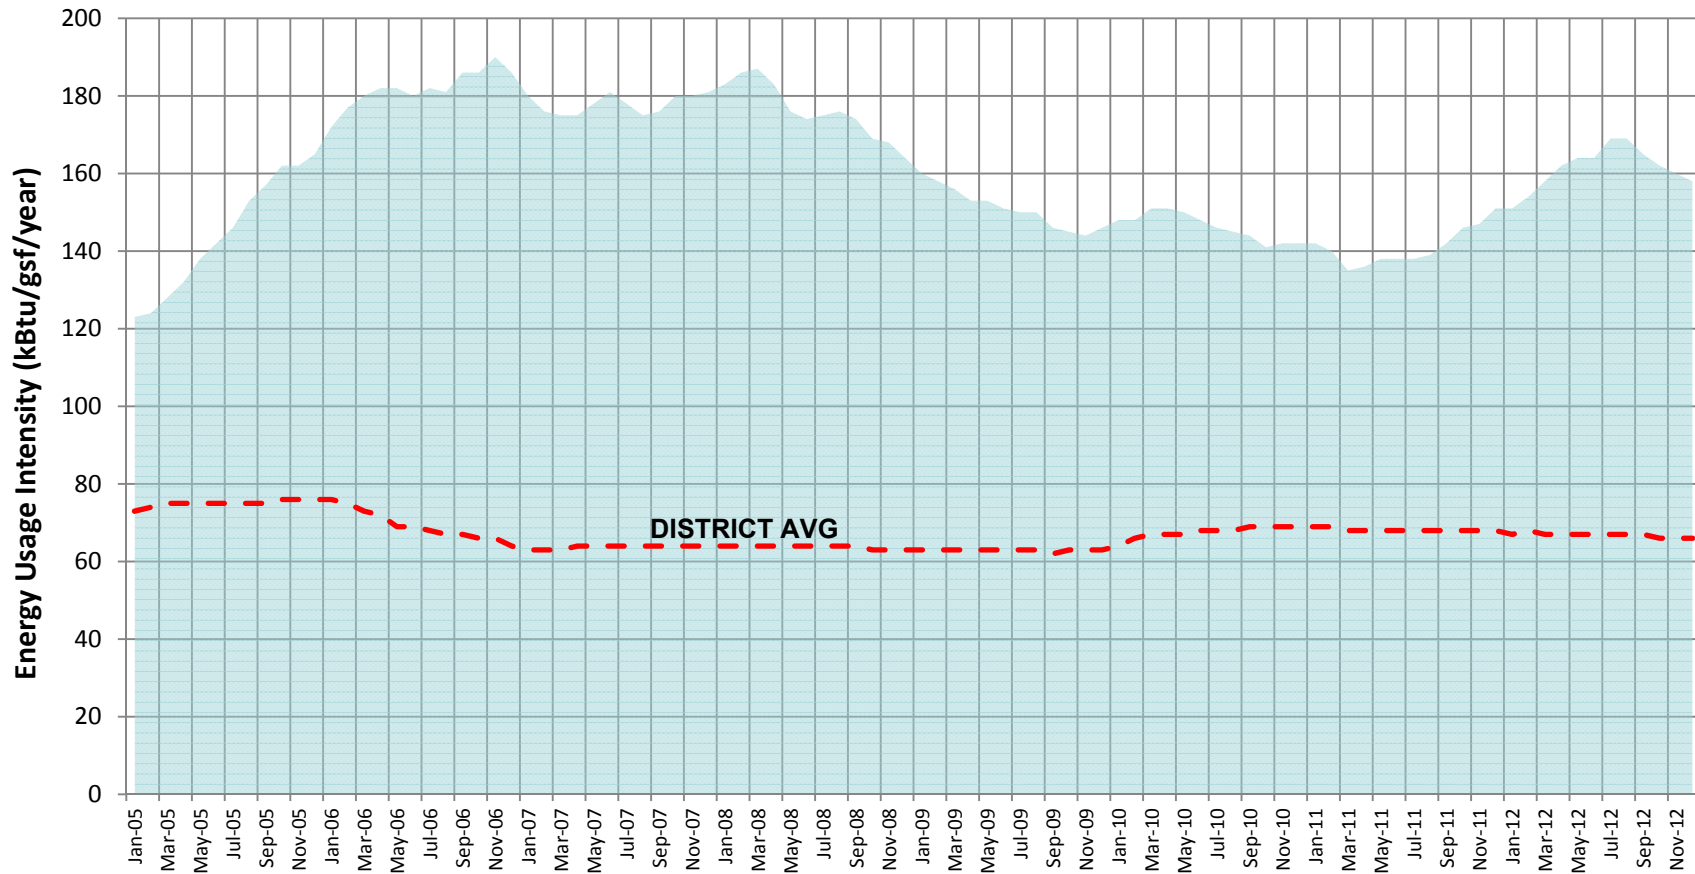
**Bailey MS: Rolling 12-Month Energy Usage Intensity (EUI) - At January 2013 (8-Yr History)**

At January 2013, the current EUI of the facility was 158 kBtu / gsf / year which was more than double the 'average EUI' of the District (66) and nearly three times the aggregate District EUI of 56.

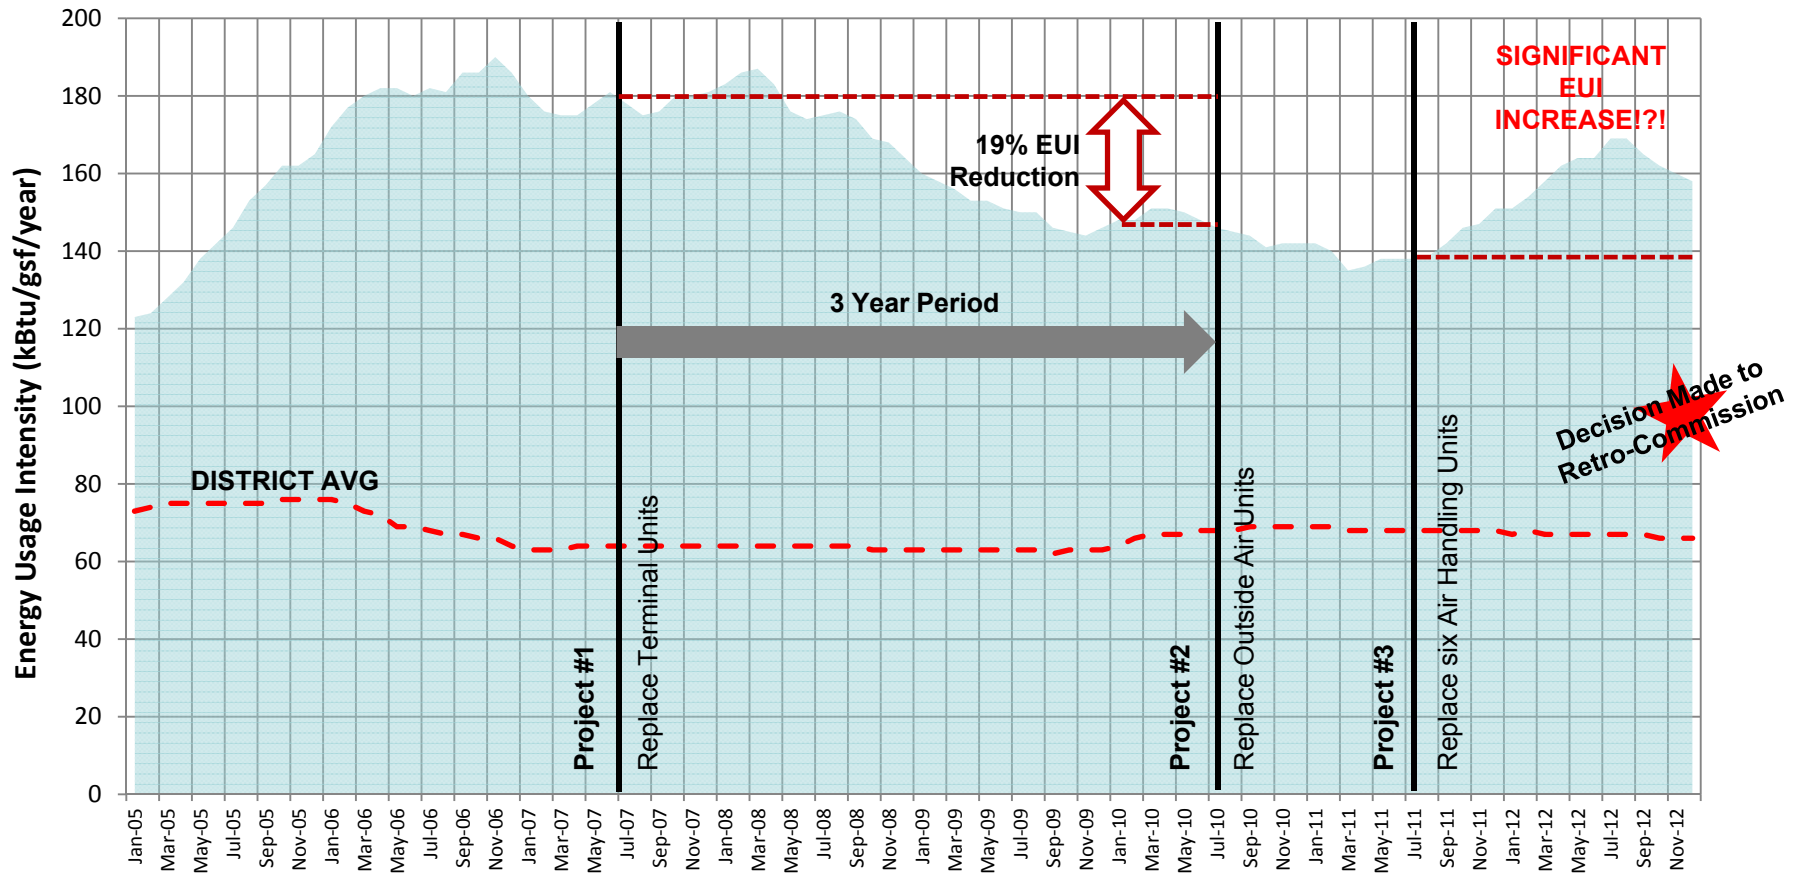
**Bailey Middle School: Rolling 12-Month Energy Usage Intensity (EUI) - At January 2013**

As HVAC Replacement projects were completed there was not significant decrease seen in the energy consumption of the campus, below chart illustrates projects completed through January 2013

*System Replacement was not resulting in significant or persistent reduction of energy consumption!*

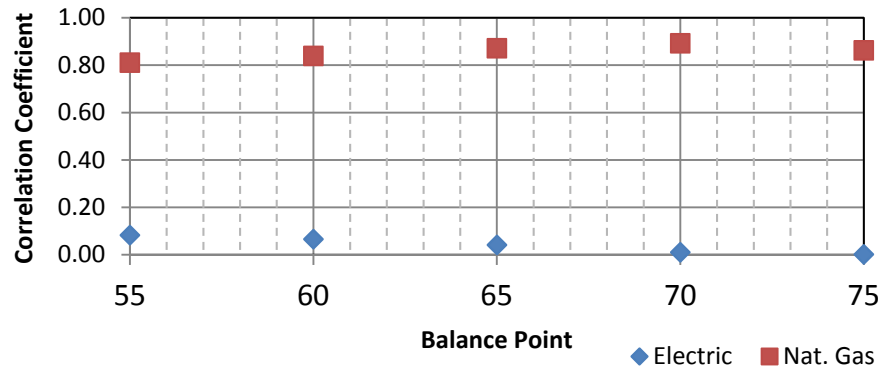
SY-2011 Cooling Degree Days

So... in SY-2011 the Natural Gas consumption had a very high correlation (above 0.80) with the Cooling DD ?!?!?

AND... Electric consumption had nearly ZERO correlation with Cooling DD ?!?!?

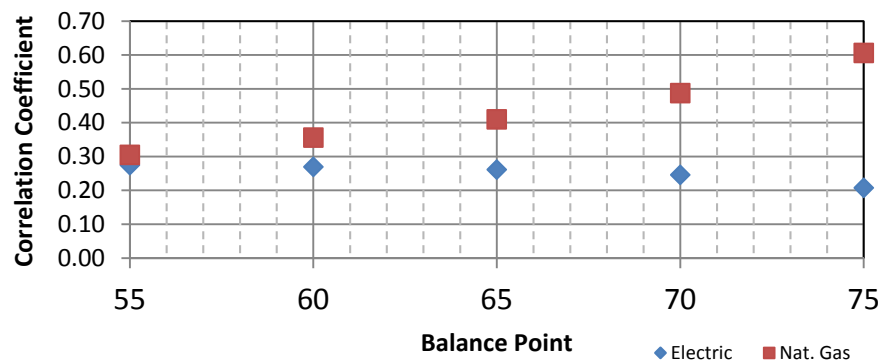
SY-2011 Heating Degree Days

**AND...** the optimum balance point for Natural Gas consumption (highest  $R^2$ ) was above 75F balance point?!

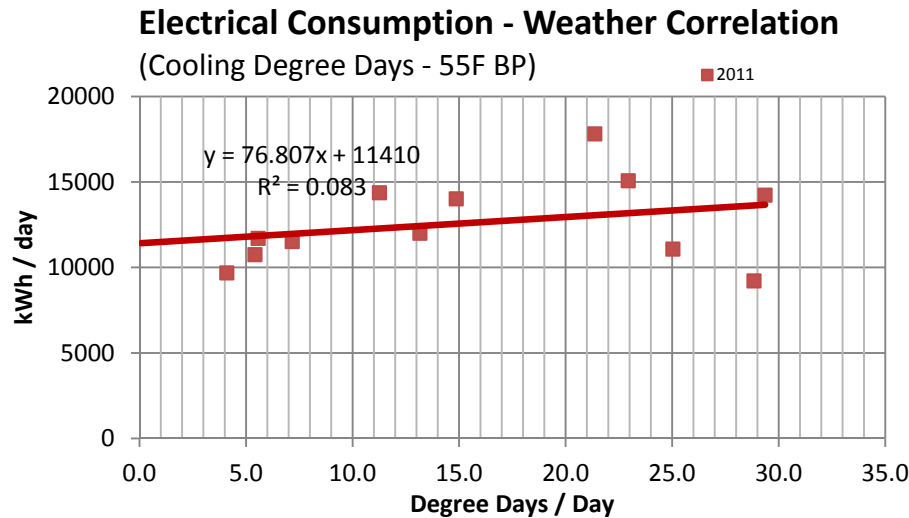
Correlation Analysis for Electrical consumption to CDD reveals very low response to weather and high baseline consumption – not as expected.

**Daily Consumption:** 11,410 kWh / day  
**Correlation:** 0.083

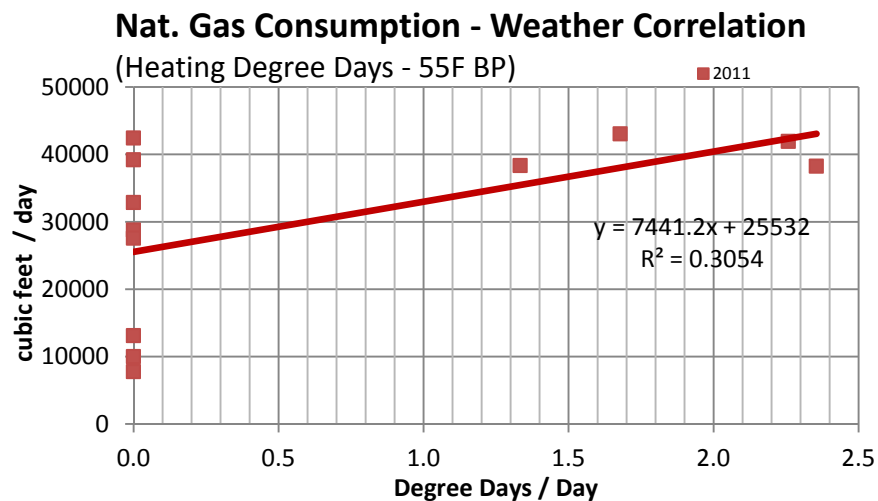
Correlation Analysis for Natural Gas consumption to HDD also indicates low response to weather and high baseline consumption – not as expected.

**Daily Consumption:** 7,441 cf / day  
**Correlation:** 0.31

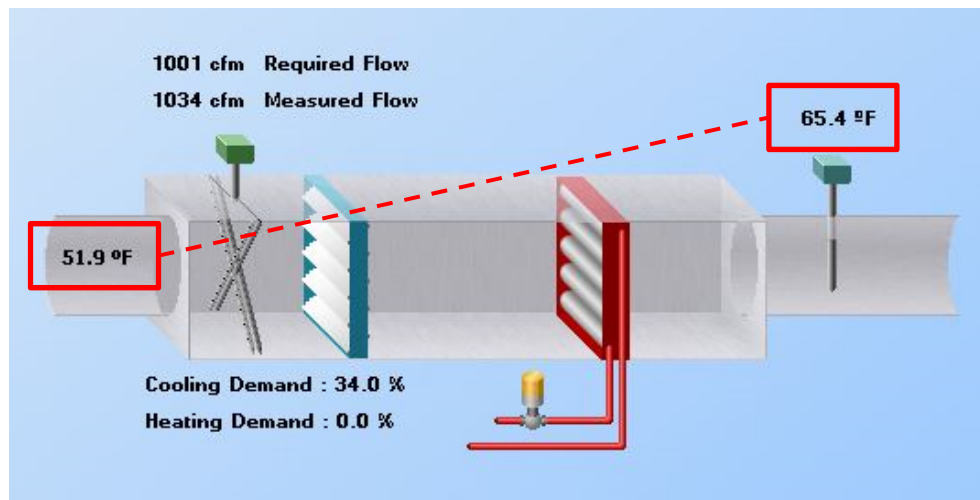
**Example: VAV Reheat Valve Failure / Leaking By**

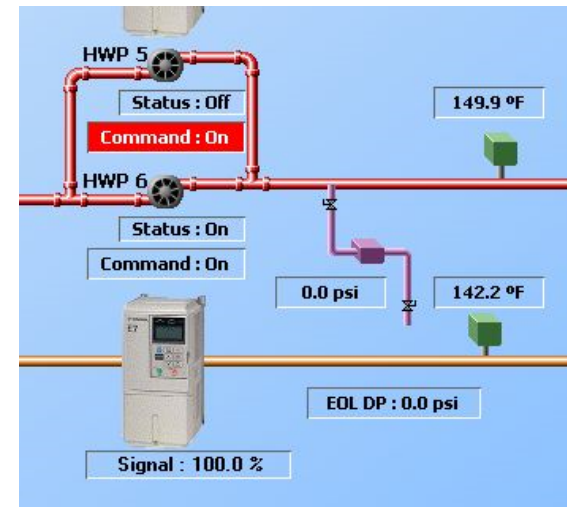
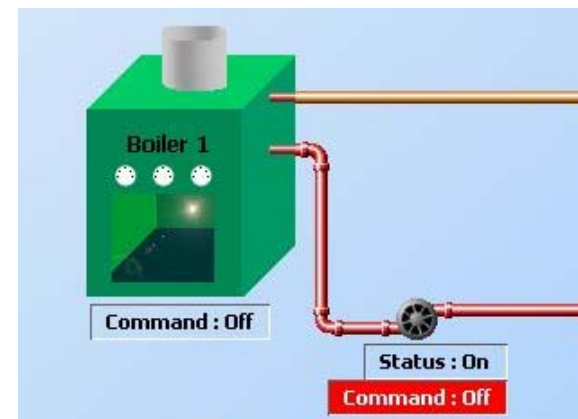
## Hot Water System Issues

- Heating water pumps running at 100% always due to failed DP sensor
- Boiler enable / disable from BAS not functioning therefore plant running continuously

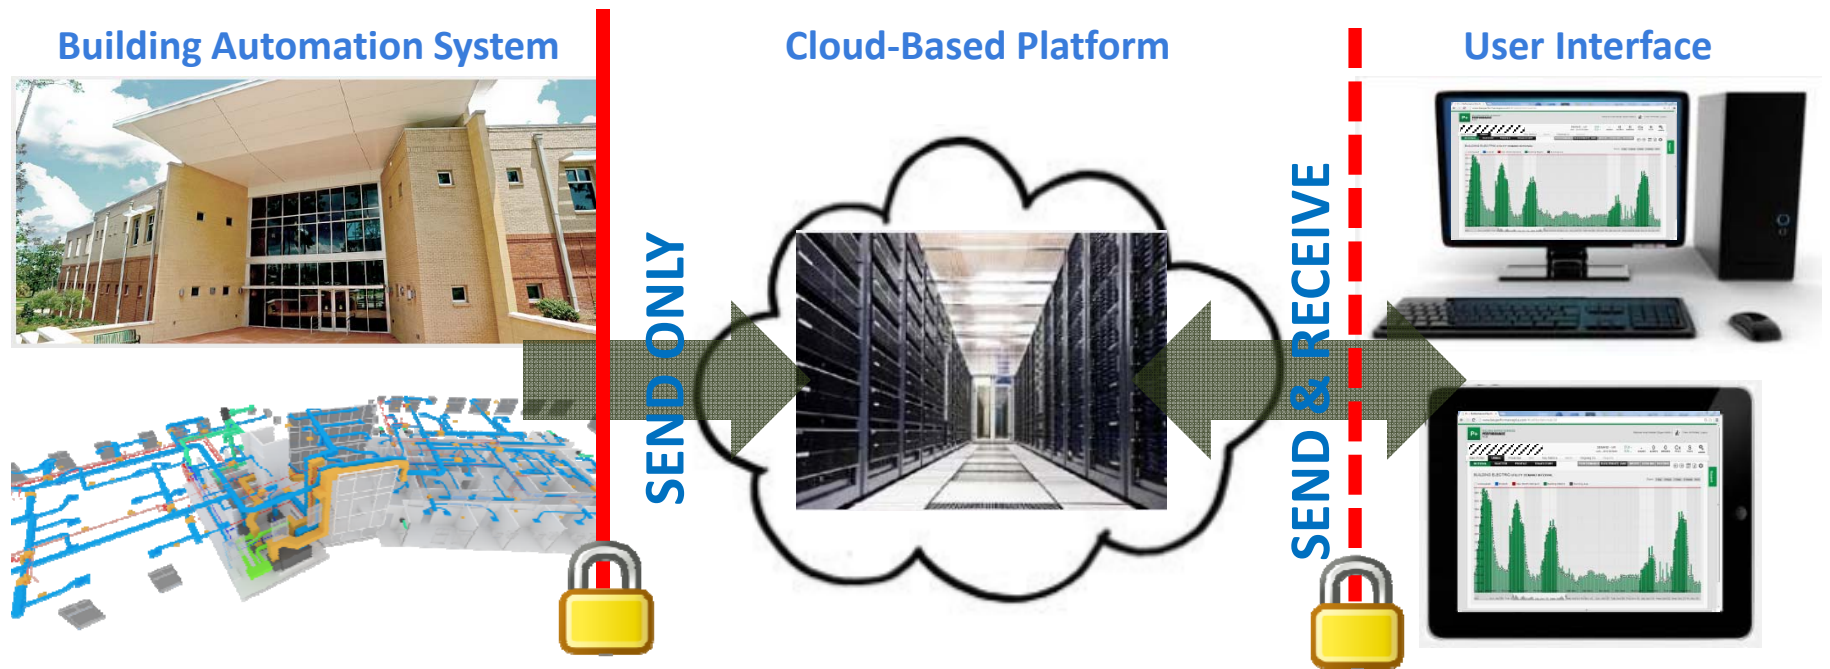
Beginning with the commissioning of the Phase 5 equipment replacement a 3rd party performance monitoring platform was utilized to verify the functional performance of the systems.

System allowed further optimization of system performance as well as automated fault detection and diagnostics (AFDD) capability to prevent system degradation and extend savings persistence.

Reports from facility BAS server are transferred (via email, FTP transfer, communicated) to the platform where it is processed and stored in a secure cloud-based enterprise database for access from any internet connected device (PC, tablet, phone) capable of HTML5 browser support

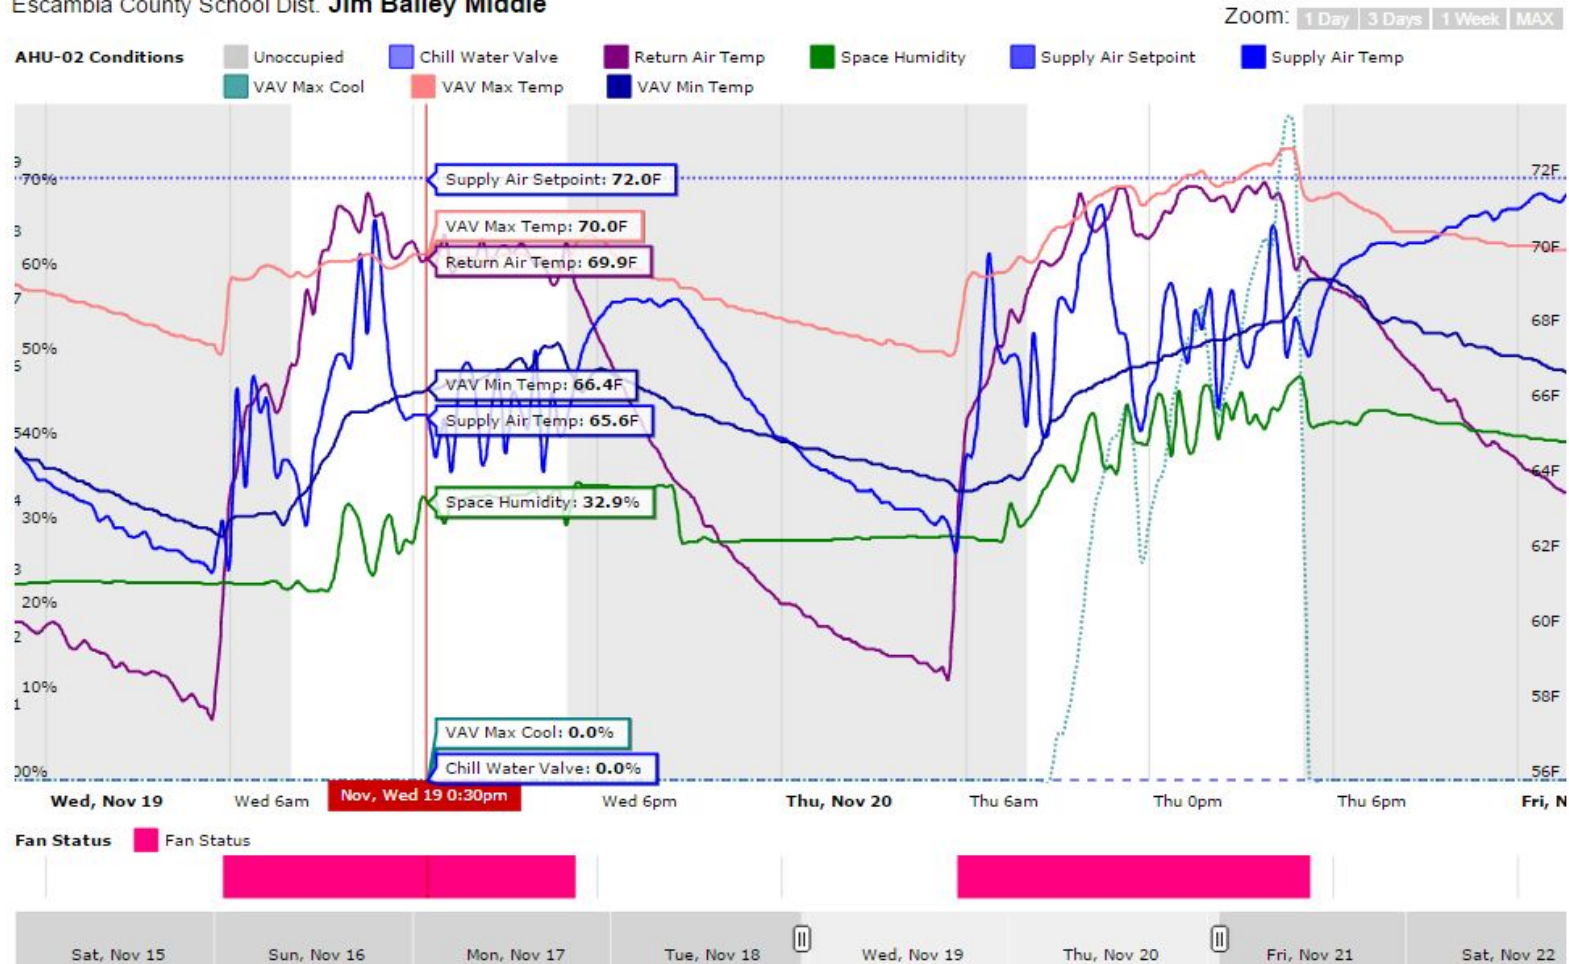
## Example Diagnostics: Chilled Water Valve Failed Open / Leaking By

Chilled water valve fails open or in last position... system continues to function fine at the space level as reheat coils 'do their job' and provide heat to offset the failed valve – this would go unseen in most cases – AFDD detects and alerts so this can be addressed!

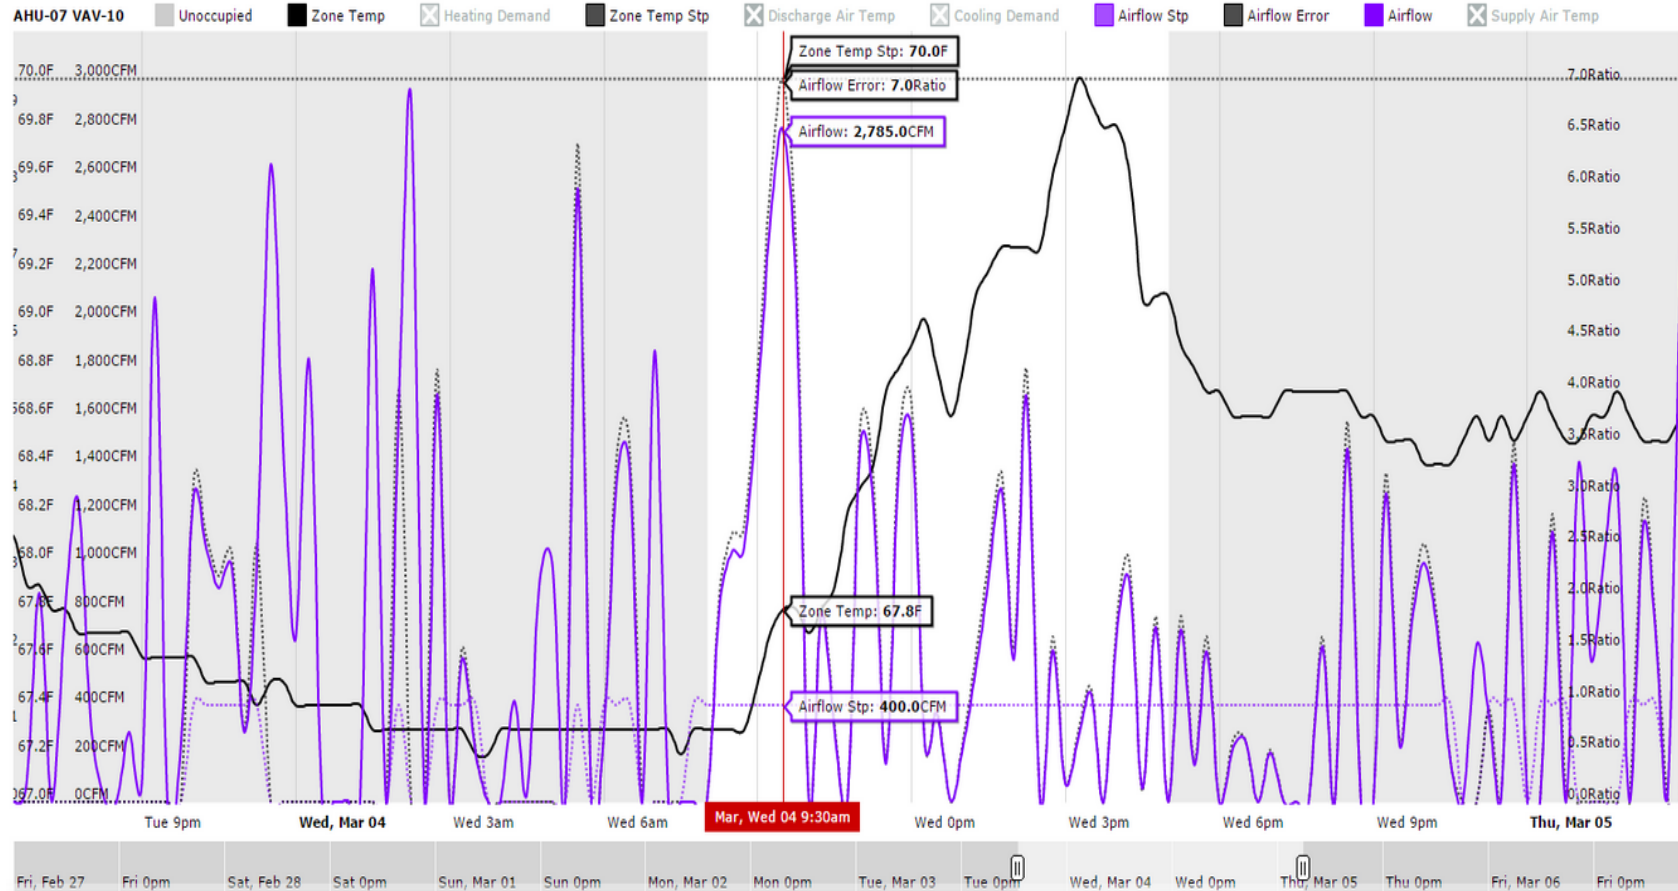
Out of control VAV airflow... wasn't causing "too bad" of space temperature control and could go without notice as the controls know 'the show must go on!' AFDD solution catches this as a performance issue even though it may not generate a comfort complaint.

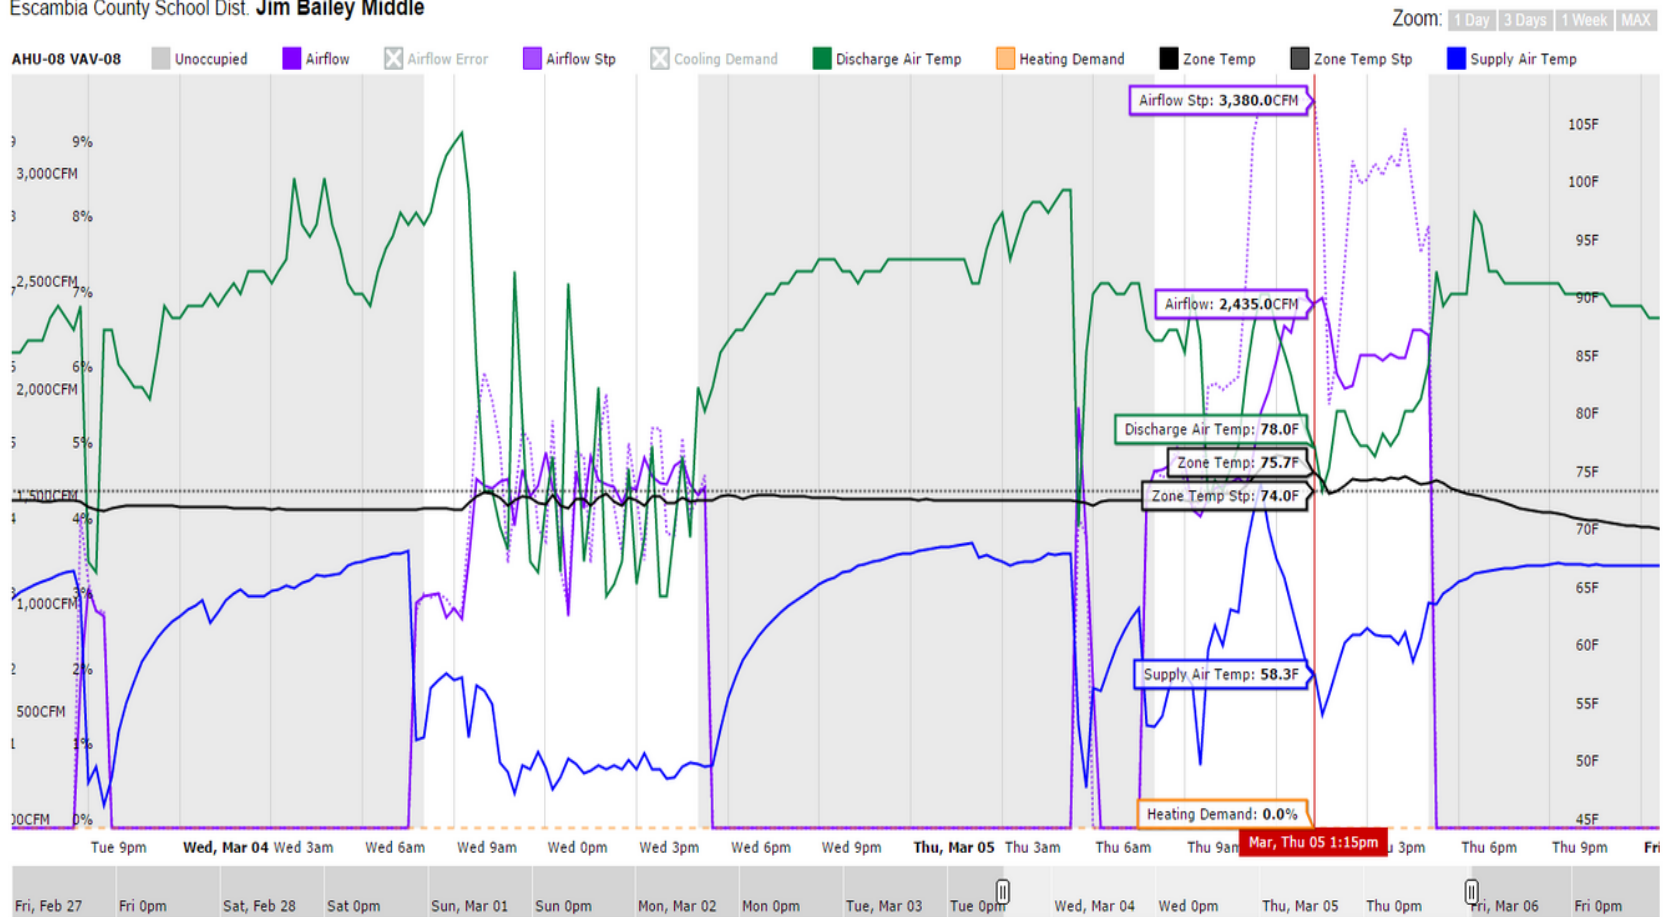
## Example Diagnostics: Terminal Unit Hot Water Valve Failed Open / Leaking By

VAV reheat coils leaking by or failing open was one of the primary contributors to this facilities original poor performance... accumulated failures occur hidden from view. This occurred AFTER all of the valves had been replaced, detected automatically, corrected in timely manner.

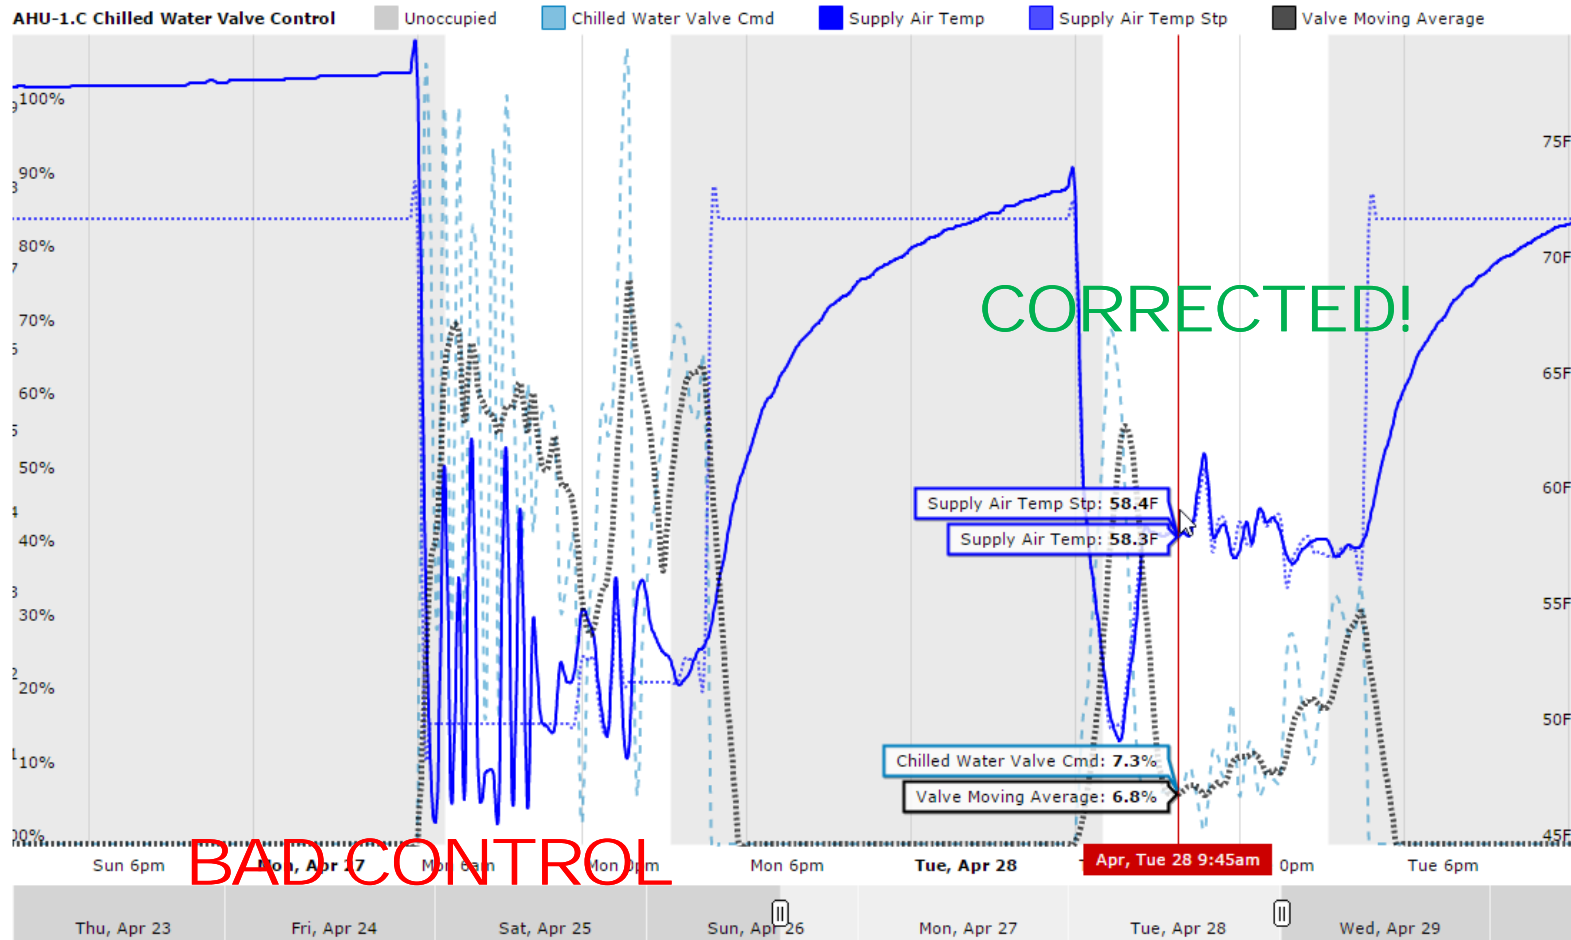
## Example Diagnostics: Chilled Water Valve Control Loop Tuning

Control loop tuning is VERY important but often over-looked... difficult at best to determine during 'snapshot' testing. Trend analysis, in this case automated, alerts Cx Analyst to conditions of poor control caused by improperly tuned control loops

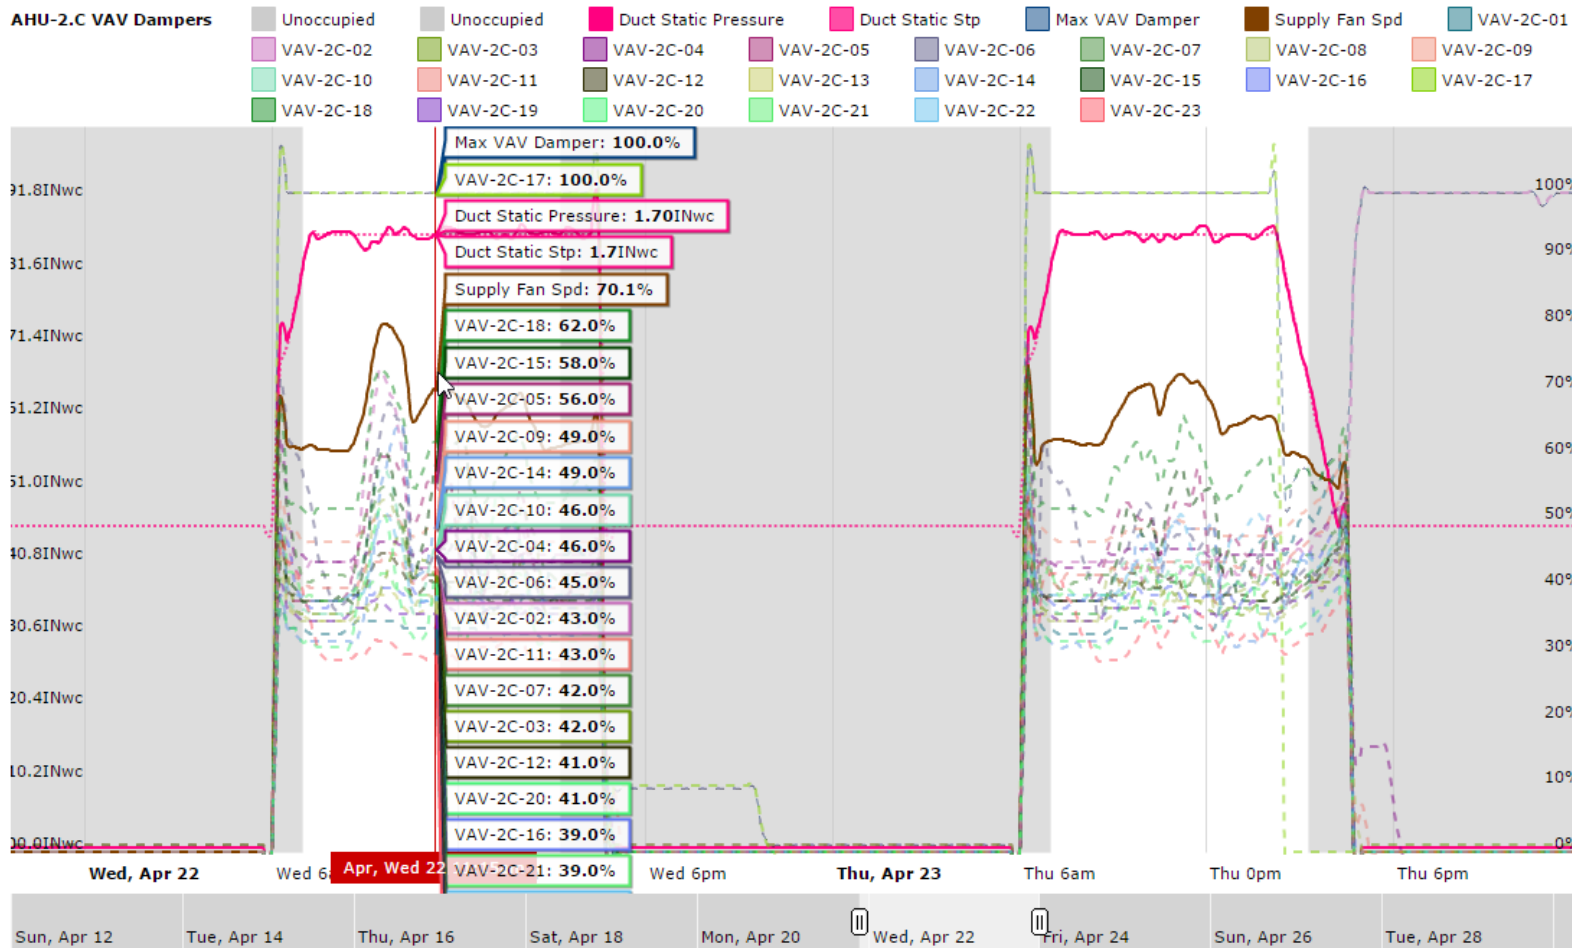
## Example Diagnostics: Optimization Routine Outlier Monitoring

A single outlier VAV terminal unit with damper at 100% open causing SP setpoint to not reset... was issue with VAV Controller. After correction the system fan decreased from 70% speed to 50% speed at same conditions... **a fan power decrease of 64%**

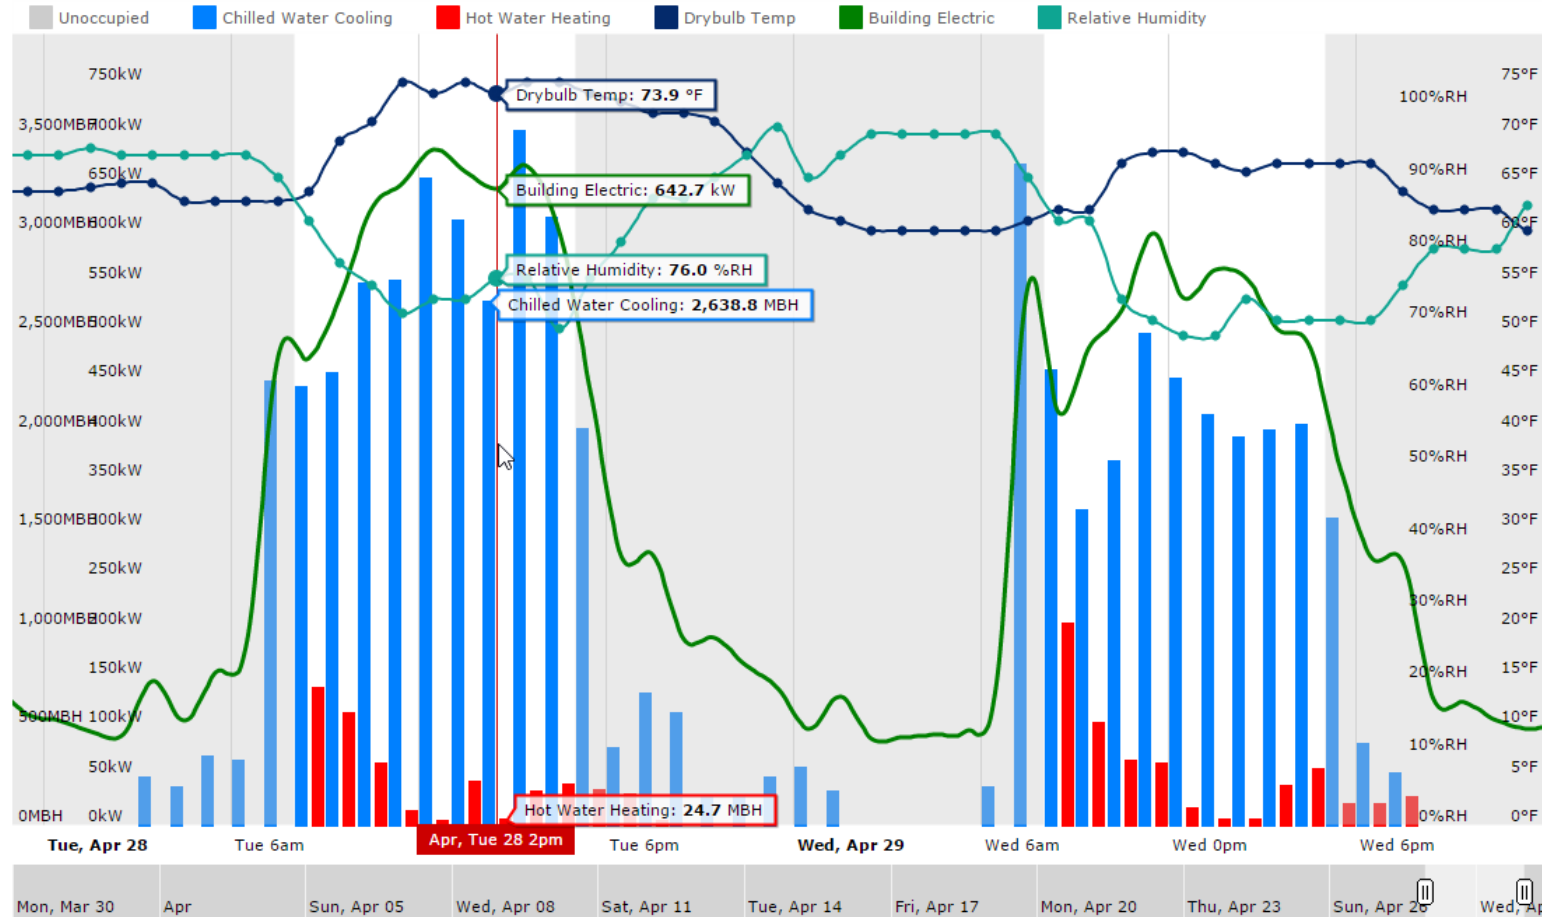
**INVALUABLE** information both from a performance analysis perspective as well as for operational logic – make metering data at the BAS level a priority on ALL projects!!! However, always keep in mind that the Utility Consumption is a dependent variable – **control the SYSTEM!**

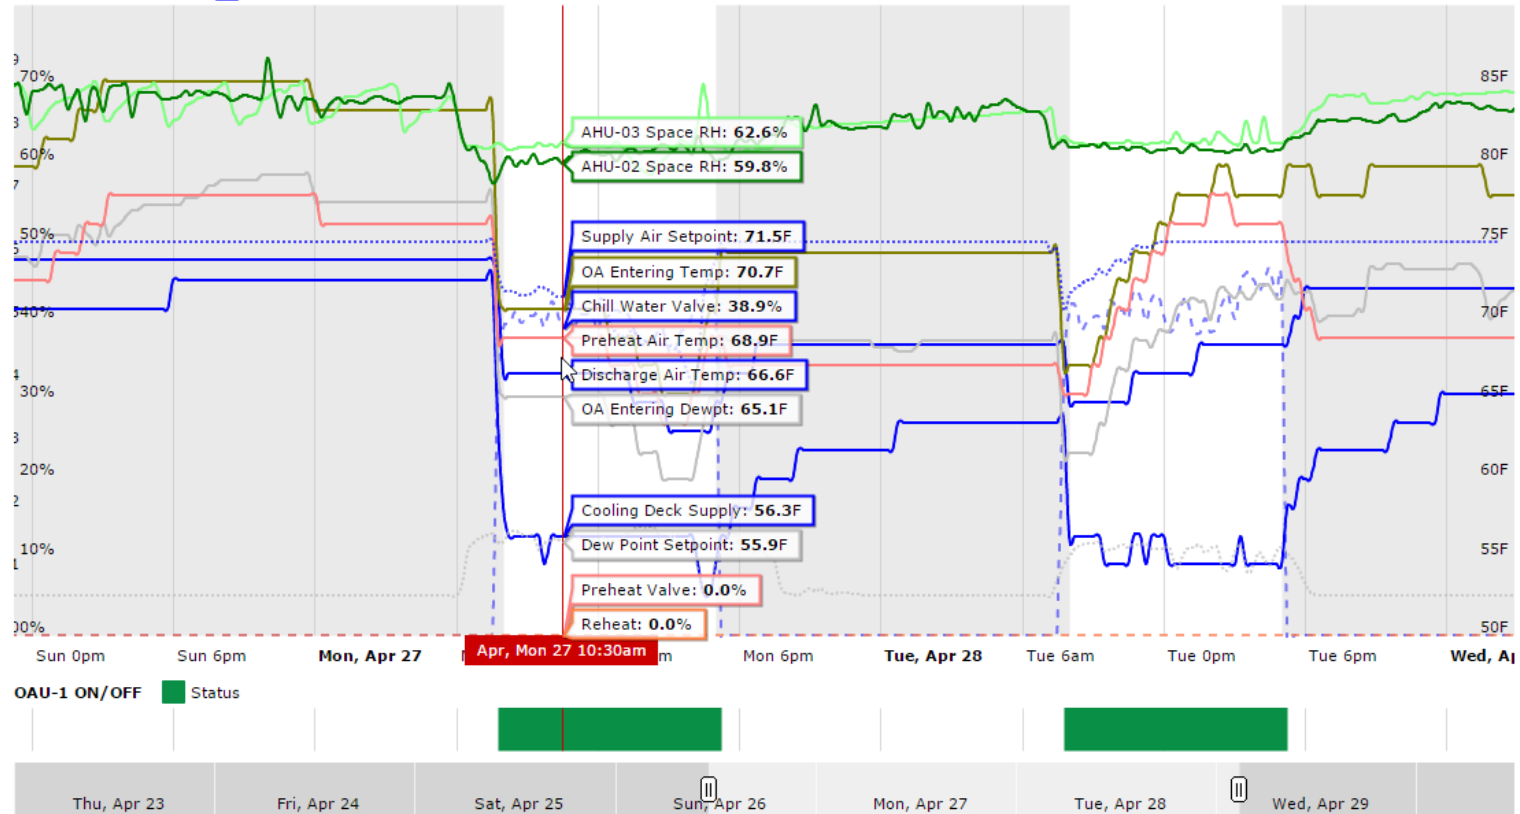
**OAU-01 Conditions**

One of the bigger energy consumption issues was the outside air units... but what was a huge energy penalty had the potential to become a very efficient system feature if it was controlled properly... optimizing dewpoint setpoint by space RH and Discharge Air temp by zone demand

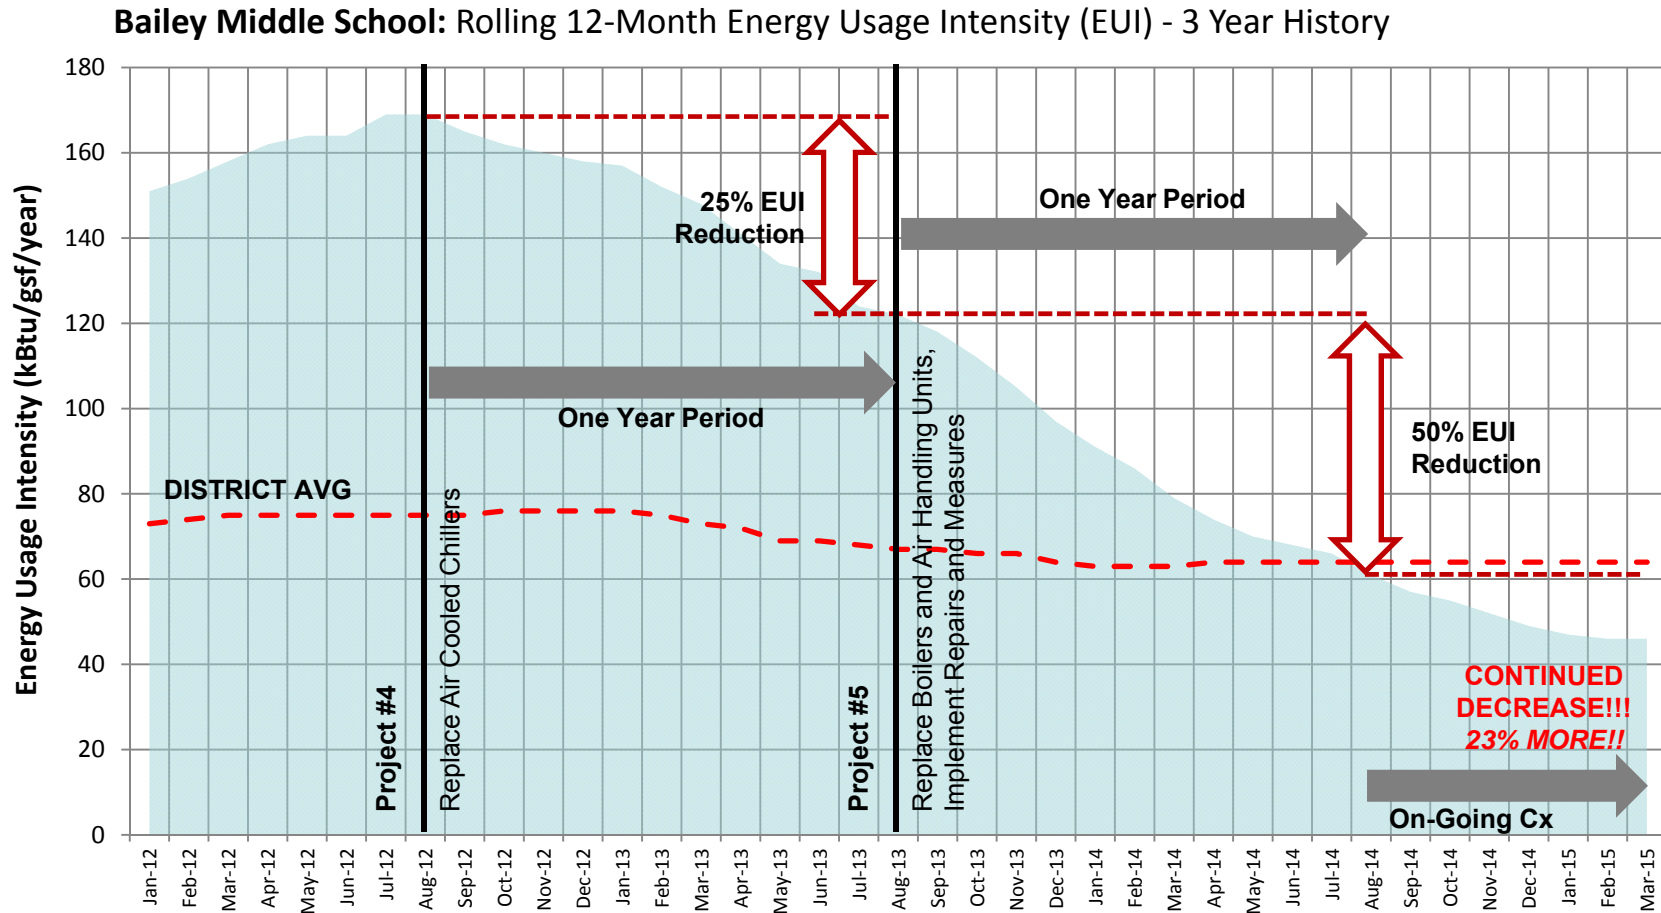
One year following completion of the chiller plant replacement the campus EUI was now 25% below 2012 peak EUI which resulted from savings primarily due to the chiller plant efficiency improvement

One year following the boiler plant replacement, retro-Cx, and implementation of all of the recommended corrections and conservation measures there was a 50% decrease in EUI!!  
**Over the next 9 months using On-Going Cx resulted in additional 23% decrease!!!**

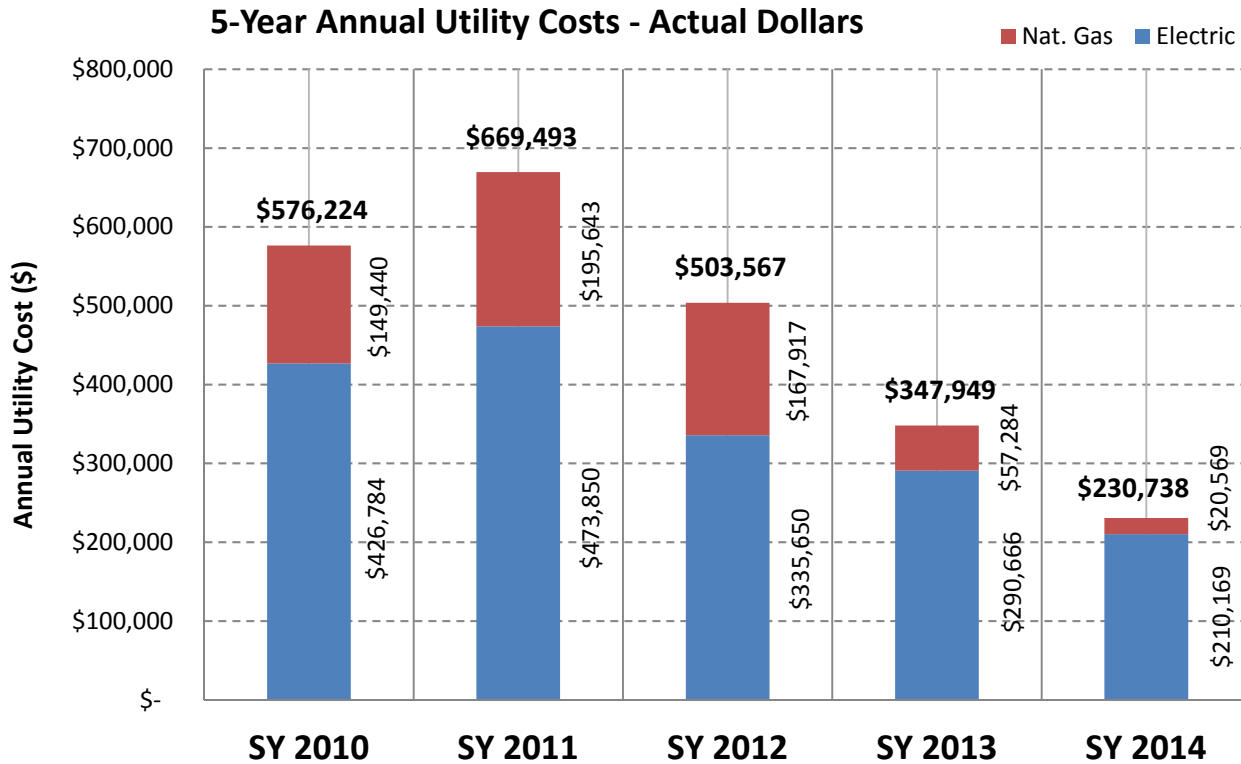
Projected gross (non-corrected) “School Year” savings for SY-2014 compared to SY-2011 are anticipated to be approximately \$410,000. This is despite a 20% increase in electrical rate over period!

The natural gas service cost for all of SY-2014 will be approximately equal to just the peak month in SY-2012 when December was around \$25,000 for that single month. Additional utility cost savings in SY-2014 attributed to On-Going Monitoring Based Cx activities are around \$75,000.

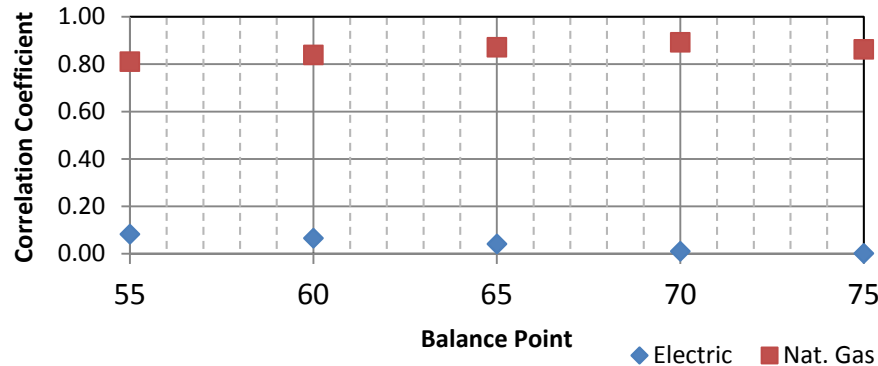
SY-2011 Cooling Degree Days

BEFORE....

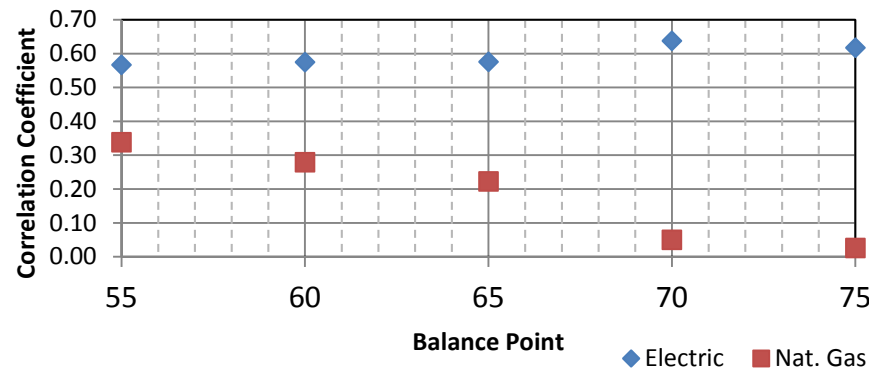
SY-2014 Cooling Degree Days

AFTER....

We see a completely different statistical relationship... Electric consumption now has a significant correlation with CDD and Natural Gas consumption does not!

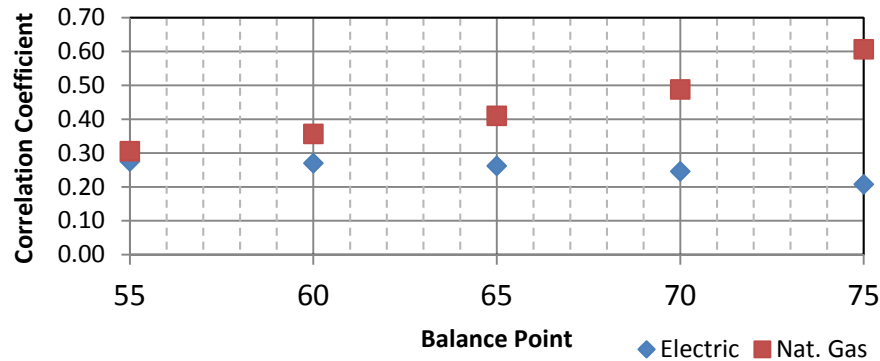
SY-2011 Heating Degree Days

BEFORE....

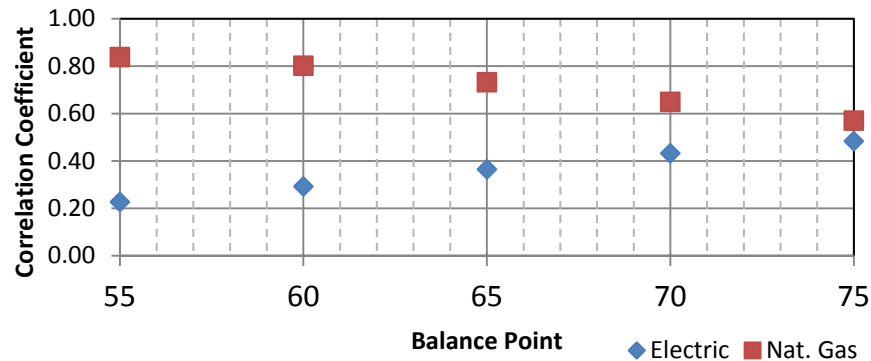
SY-2014 Heating Degree Days

AFTER....

Gas consumption now is very well correlated to HDD and the optimum balance point is at or below 55F as it should be!
