#### Preserving the World's Art and Artifacts through Existing Building Commissioning

Ryan Lean, P.E., LEED AP Molly Dee, LEED GA, WELL AP Jaros, Baum & Bolles

April 27, 2017

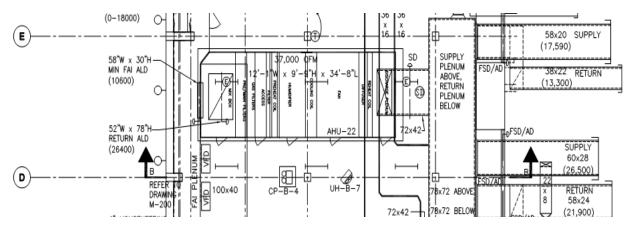
Gallery HVAC Upgrades from 2008 - 2016

- New centralized custom-built air distribution system
  - Headered variable air volume AHU's with RF's
  - Network of VAV's with hot water reheat capabilities
  - Automated temperature controls with monitoring

- Multiple phases completed by different teams of CM's, Contractors, Balancers
- System startup and implementation in phases to keep Museum in operation

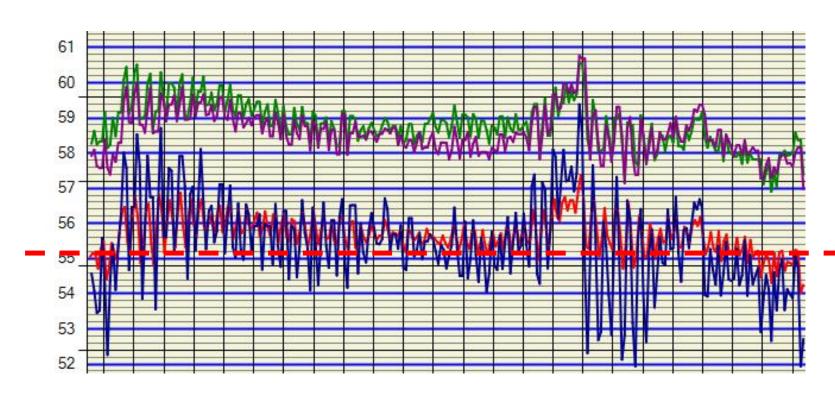
Humidity in Galleries May 12, 2016

Noisy and Outside of Acceptable Range

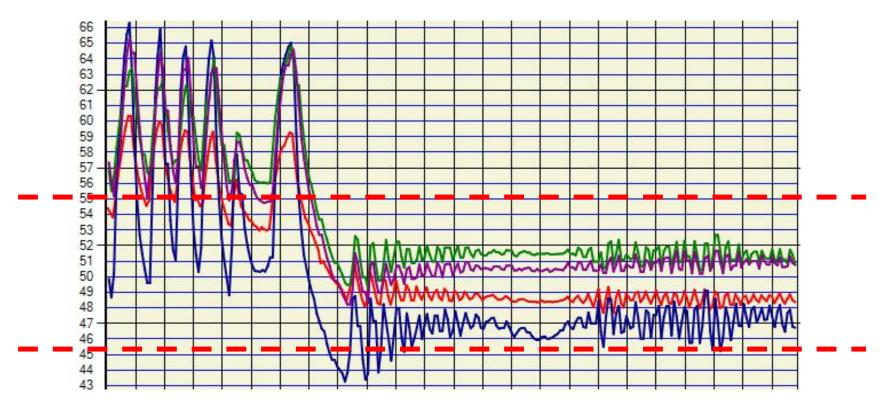
Humidity in Galleries May 20, 2016

Still Noisy, but Closer to Acceptable Range
